PERRINS MARSH DAM

NDI I.D. PA-0886,  
DER I.D. 066-005  
OWNER: MR. ELMER REESE

PHASE I INSPECTION REPORT  
NATIONAL DAM INSPECTION PROGRAM

PERRINS MARSH DAM  
NDI I.D. PA-0886  
DER I.D. 066-005  
NOVEMBER 10, 1980

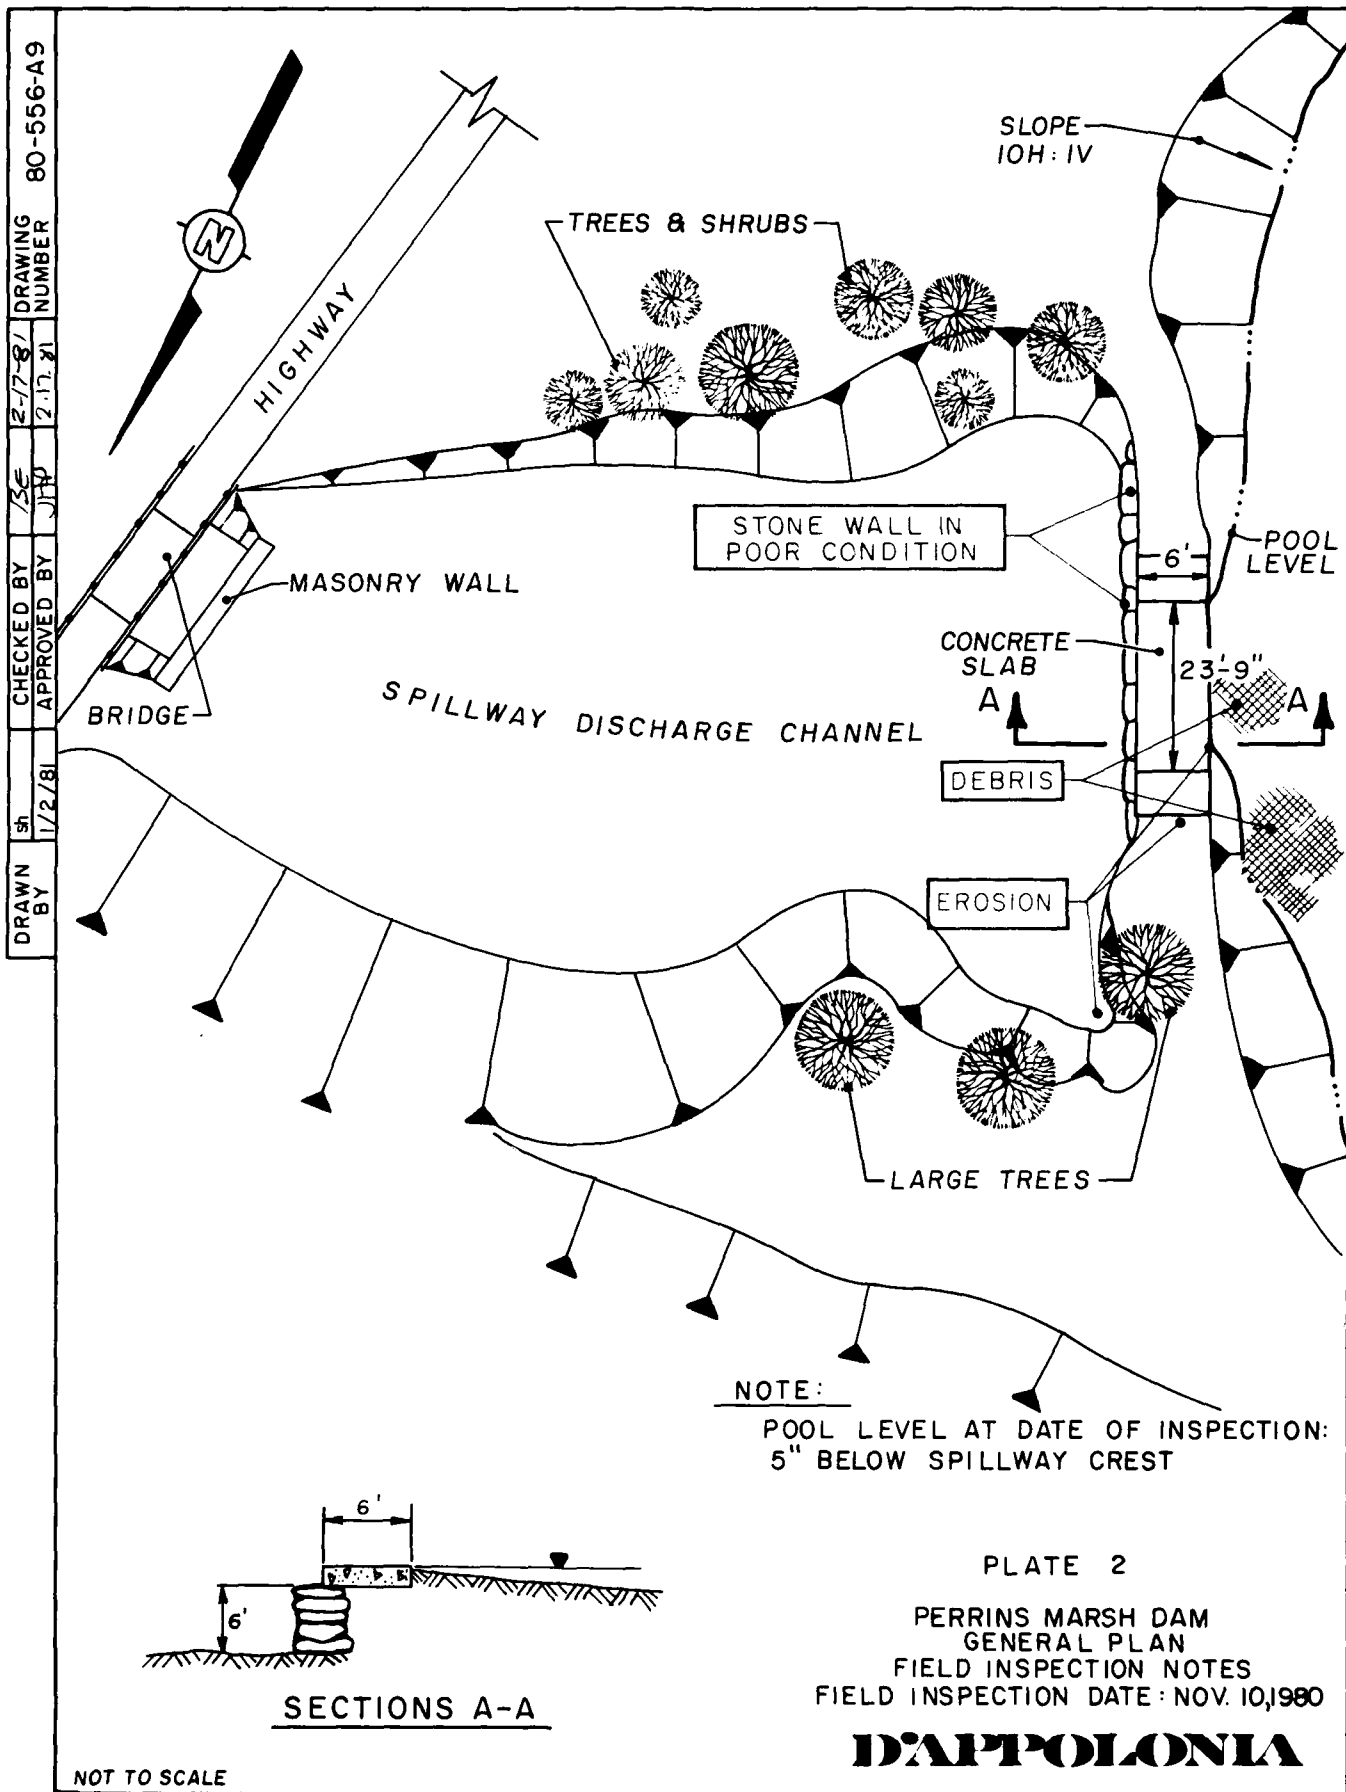
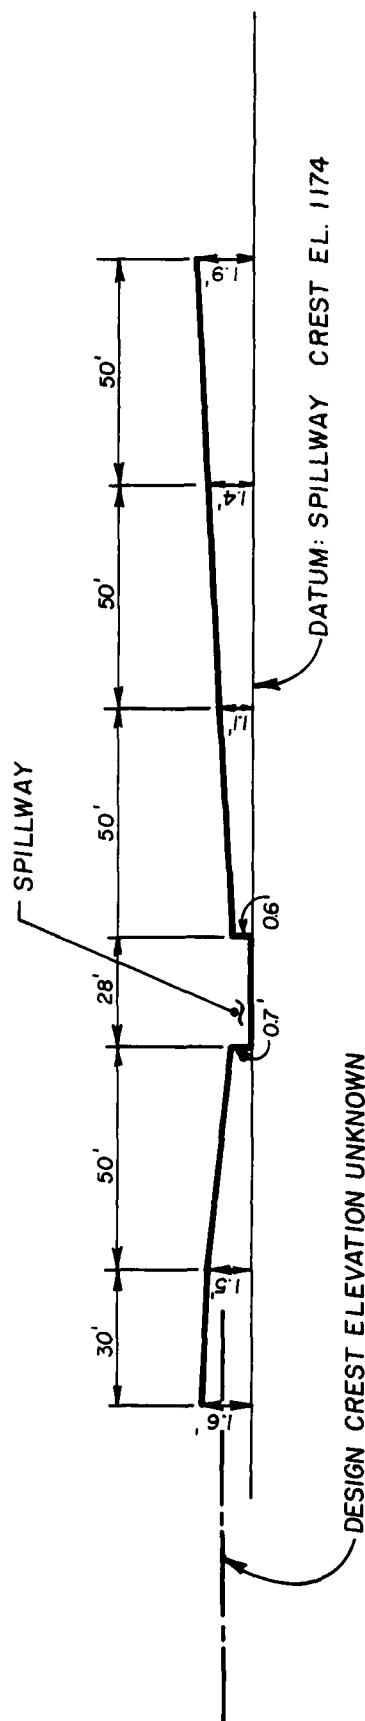
# **DAM CREST PROFILE** (LOOKING DOWNSTREAM)

The top of the dam and the abutment sections were surveyed relative to the overflow section of the dam. The profile is illustrated in Plate 3.
